Ultrasonographic Diagnosis of a Knee Prosthesis Polyethylene Loose Body: A casereport

以超音波診斷人工膝關節之聚乙烯鬆落體：病例報告

Ultrasonographic Diagnosis of a Knee Prosthesis Polyethylene Loose Body: A Case Report

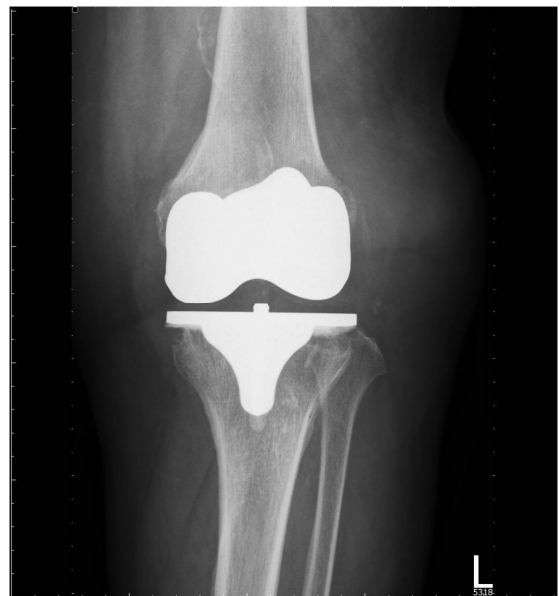
圖 1. 患者之膝部 X 光:無特殊發現

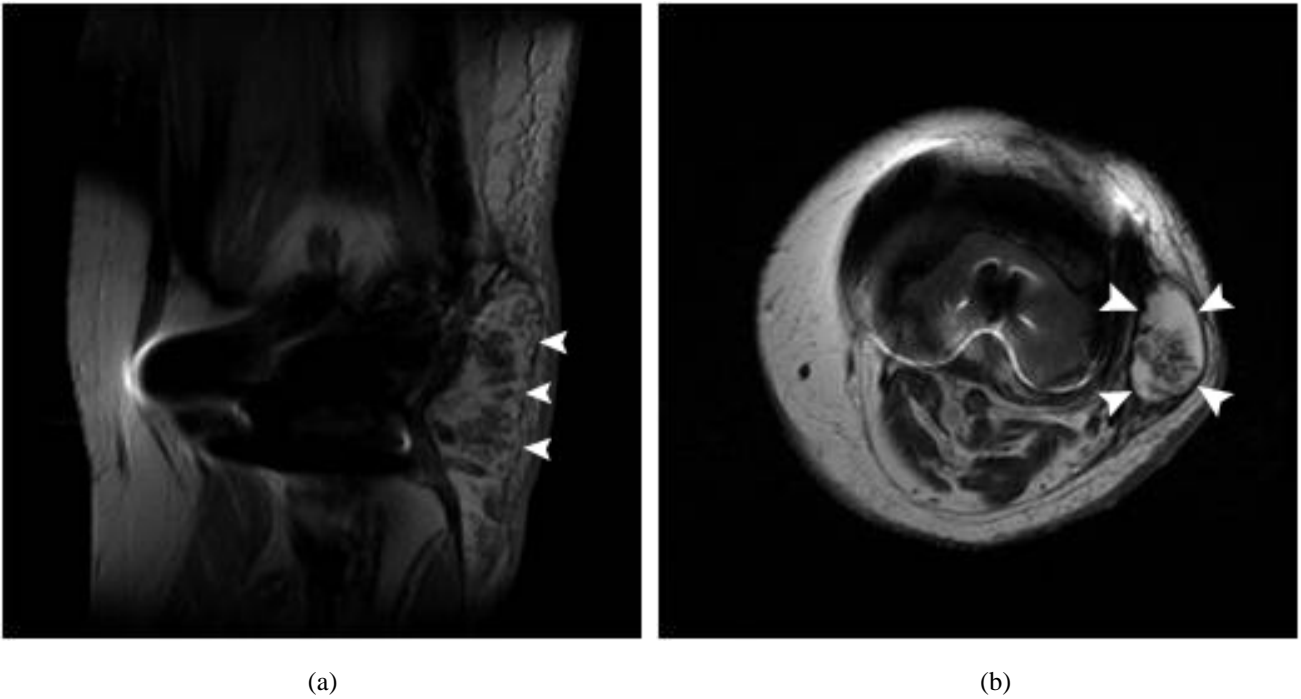
圖 2. (a)核磁共振影像：冠狀切面。箭頭所指處為膝部異質性分葉囊腫，內部有低訊號之結節。(b)核磁共振影像：橫切面。箭頭所指處為膝部異質性分葉囊腫，內部有低訊號之結節

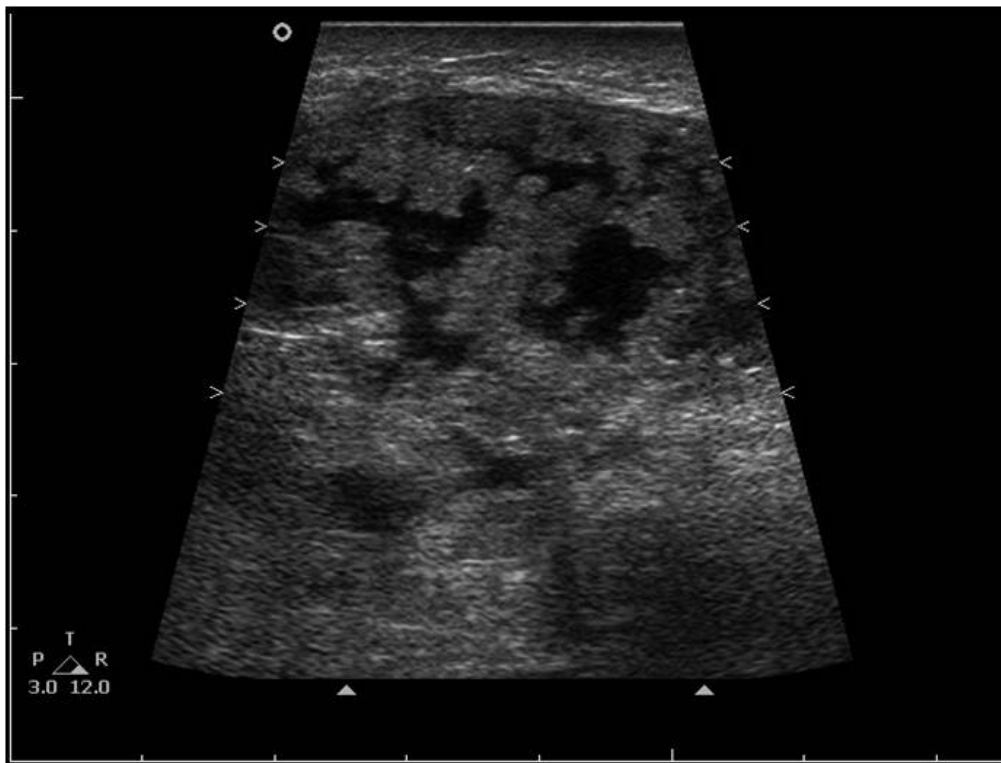
圖 3. 膝部腫塊之超音波影像：圖中無回音部分為液體;高回音部分為增生之肉芽組織，其影像與病理切片結果相符

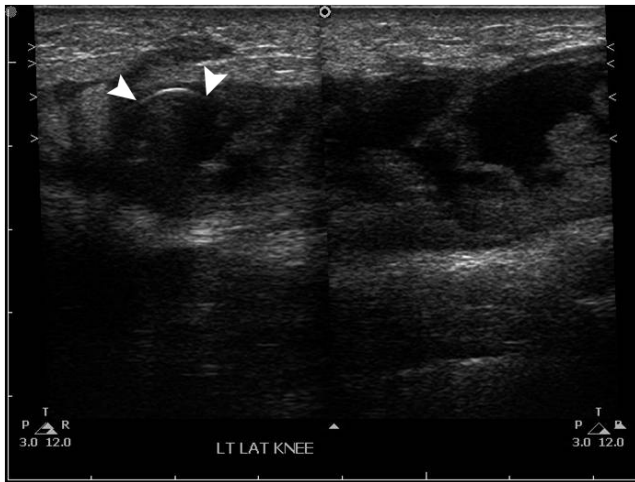
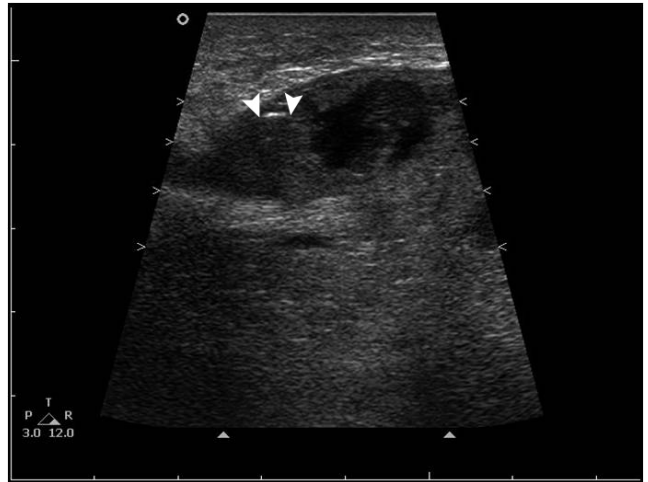
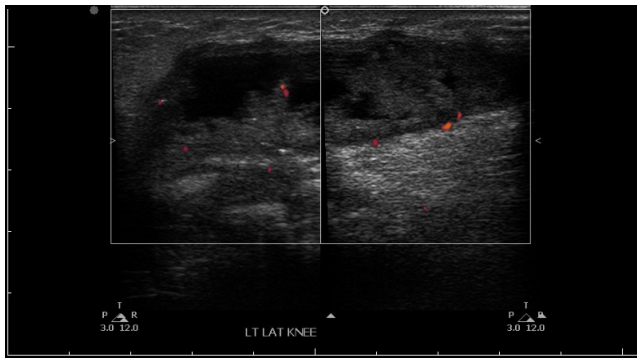
患者之左膝關節 X 光前後照及側照檢查顯示無特殊發現(圖 1)。因病人腎功能不佳，故核磁共振選擇不施打顯影劑。在施打顯影劑之核磁共振檢查中，人工膝關節金屬植入物呈現明顯假影，於左膝外側關節邊緣發現一大小為 2.6×4.5×10.5 公分之異質性分葉囊腫(lobulated heterogenous cyst)，內部為在 T1 及 T2 weighted image 均為低訊號之結節，在 T2 weighted image 可看到混合高訊號液體，此結節與膝關節內部相通；核磁共振診斷為疑似色素沉著絨毛結節性滑膜炎或感染性滑囊炎(圖 2a, 2b)。患者同時接受肌肉骨骼超音波檢查，我們使用 Phillips Envisor 超音波儀(Phillips, USA)配合 5~12MHz 探頭進行檢查，於左膝外側發現有無回音性、後側增強，經探頭壓迫為可壓迫性之大量液體聚積、滑液膜增生之腫塊，且於都卜勒超音波下可進一步觀察到充血。此外，於腫塊內部發現一 8×2 公厘之高回音性線形構造，且無鈣化或金屬碎片後側陰影之典型表現，故初步排除鈣化及金屬碎片脫落，當時即懷疑為聚乙烯之鬆落體(圖 3、圖 4a、圖 4b、及圖 4c)。

圖 4. (a)超音波影像：縱切面。箭頭所指處為聚乙烯鬆落體；鬆落體旁無回音部分為液體，高回音部分為增生之肉芽組織。(b) 超音波影像：橫切面。箭頭所指處為聚乙烯鬆落體；鬆落體旁無回音部分為液體，高回音部分為增生之肉芽組織。(c)都卜勒超音波影像：可見到腫塊中有血流訊號

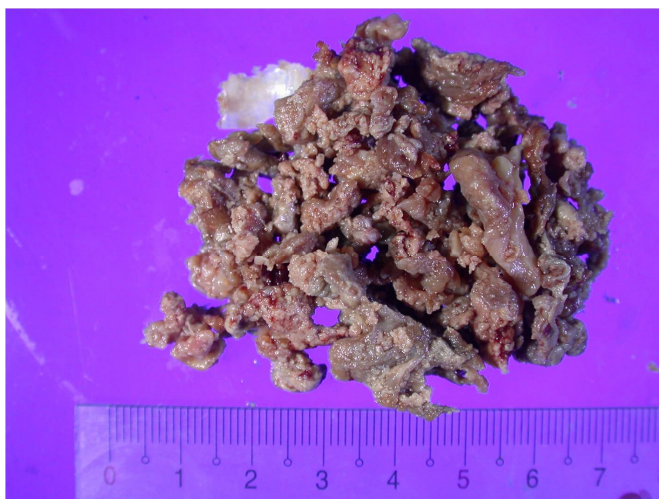
患者於超音波檢查後接受手術切除囊腫，囊腫之病理切片證實為聚乙烯之碎片包覆在組織巨細胞中，並有肉芽組織增生(圖 5、圖 6)，與肌肉骨骼超音波的檢查結果相符。患者於三個月後接受關節重建手術，術後恢復良好。

圖 5. 手術摘除之腫塊相片，含有肉芽組織與聚乙烯鬆落體

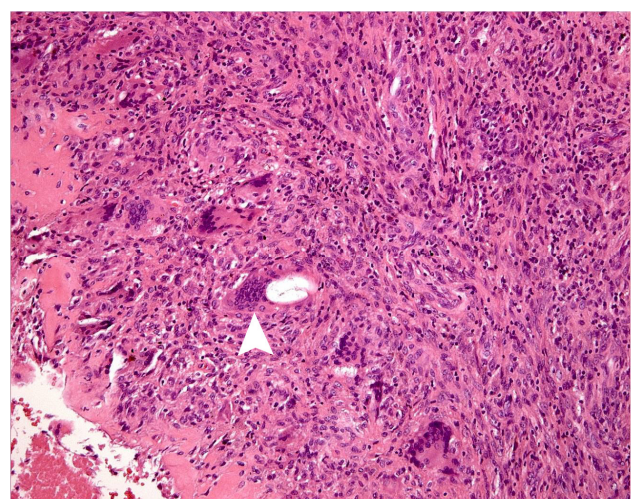
圖 6. 肉芽組織病理切片相片，100 倍放大。箭頭所指為噬入聚乙烯碎片的多核巨細胞，旁邊有大量發炎細胞，伴有纖維化變化
